Report No:	SZ09132021017
Date:	2021/09/13
Page:	1/8

# Project Inspection Report

Company : NA  
Address : NA  
Sample Name : AH3761-WG-7  
Manufacture : DIODES  
Date Code : N/A  
Package Type : SOT23  
Sample Number : 10 PCS  
Check Number : 10 PCS  
Date of Received : 09/09/2021  
Date of Tested : 10:00/09/10/2021 ~ 12:00/09/10/2021

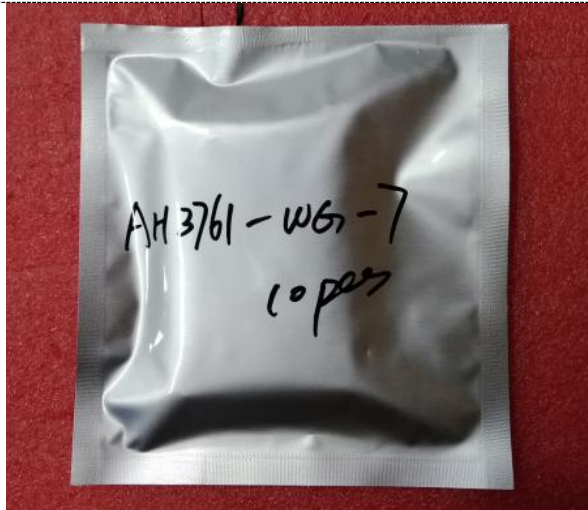
Received View-1

Gross Weight	25 g	Parts Total	10 PCS
Number Of Boxes	N/A	Full Label	Acceptable
Package type	Bulk	Moisture protection	Non Present
MSL	N/A	ESD protection	Acceptable
