Report No:	SZ09142021006
Date:	2021/09/14
Page:	1/26

Project Inspection Report

Company : NA
Address : NA
Sample Name : TPD2EUSB30DRTR
Manufacture : TI
Date Code : N/A
Package Type : SOT-9*3
Sample Number : 3 PCS
Check Number : 3 PCS
Date of Received : 09/01/2021
Date of Tested : 14:00/09/01/2021 ~ 18:00/09/03/2021

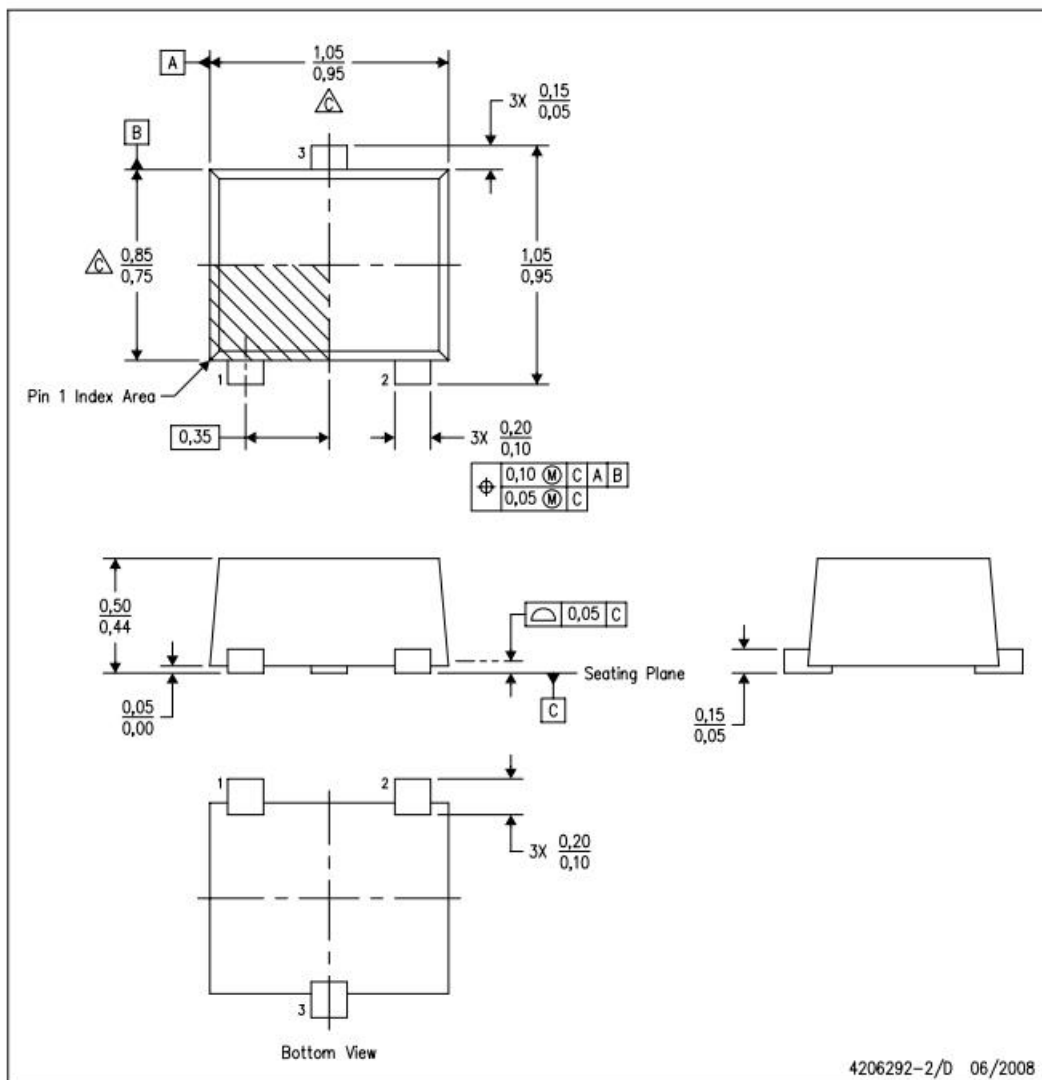
2. Package Dimensions:

The TPD2EUSB30, TPD2EUSB30A, and TPD4EUSB30 are 2 and 4 channel Transient Voltage Suppressor (TVS) based Electrostatic Discharge (ESD) protection diode arrays. The TPDxEUSB30/A devices are rated to dissipate ESD strikes at the maximum level specified in the IEC 61000-4-2 international standard (Contact). These devices also offer 5 A (8/20 μs) peak pulse current ratings per IEC 61000-4-5 (Surge) specification.

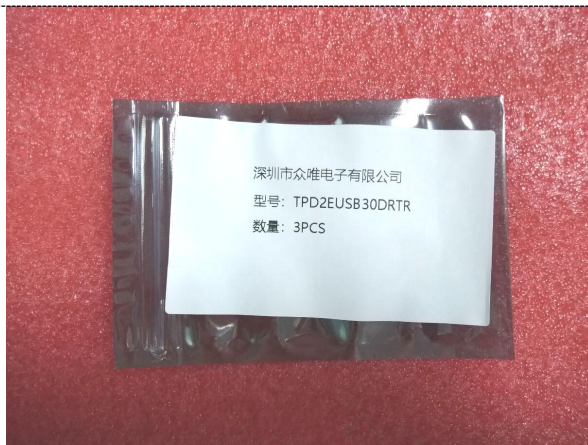
Received View-1

Gross Weight	2.3 g	Parts Total	3 PCS
Number Of Boxes	N/A	Full Label	Non Present
Package type	Reel	Moisture protection	Non Present
MSL	N/A	ESD protection	Acceptable

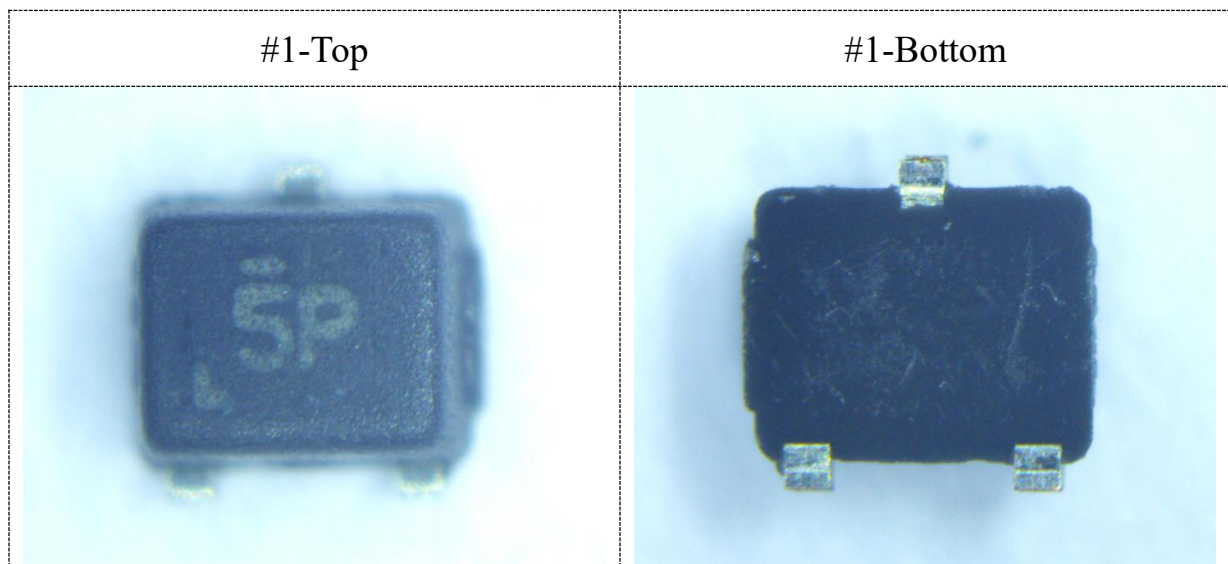
External Visual Inspection on 3 PCS(#1-#3) samples. No secondary coating, sanding marks, crack or chips were observed on all inspected. Leads were in acceptable condition. Devices package and dimension matched to manufacturer's specification. All devices passed the external visual inspection. Device passed top permanency tested.

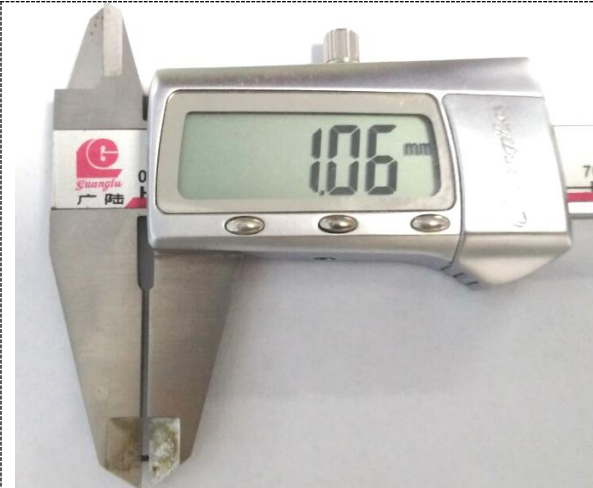
A: 0.95-1.05 MM

#1-A = 1.06 MM

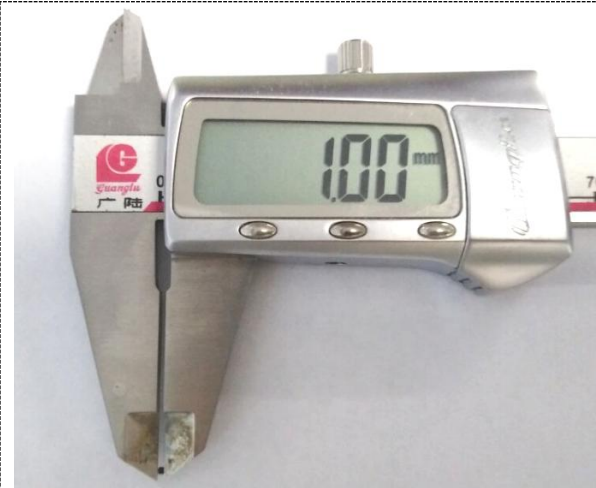
B1: 0.95-1.05 MM

#1-B1 = 1.00 MM

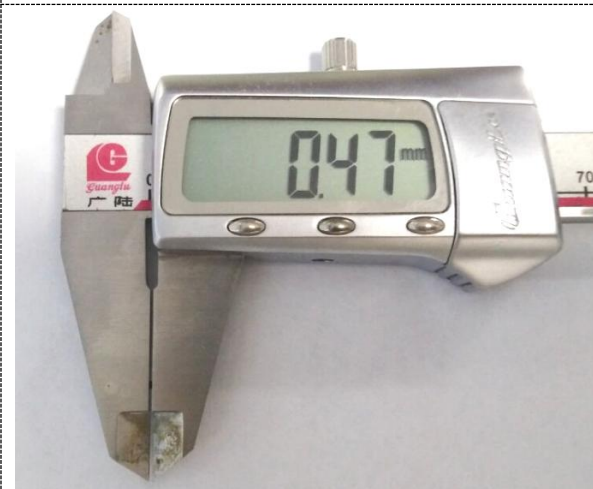
C: 0.44-0.50 MM

#1-C = 0.47 MM

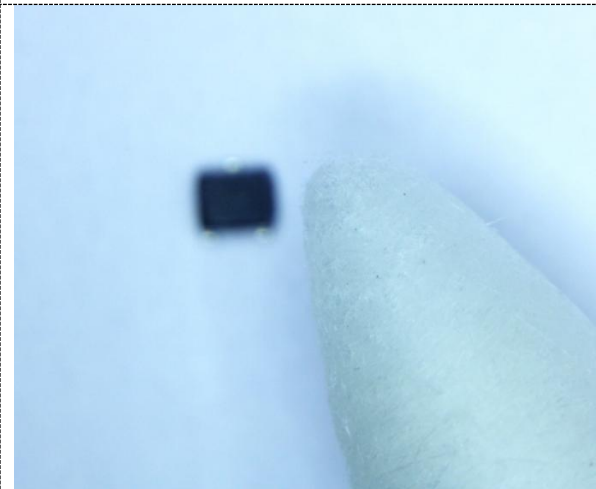
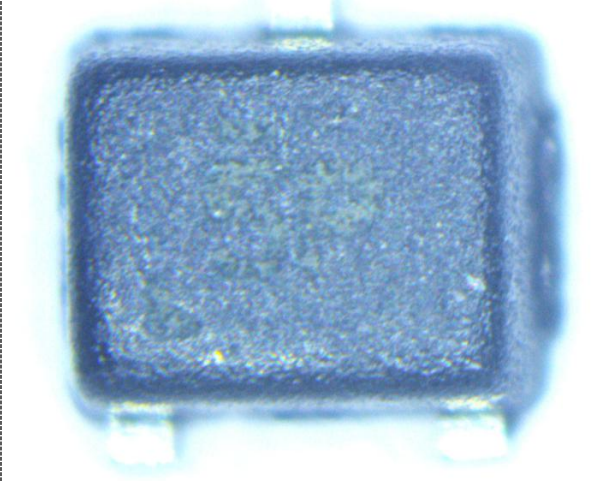
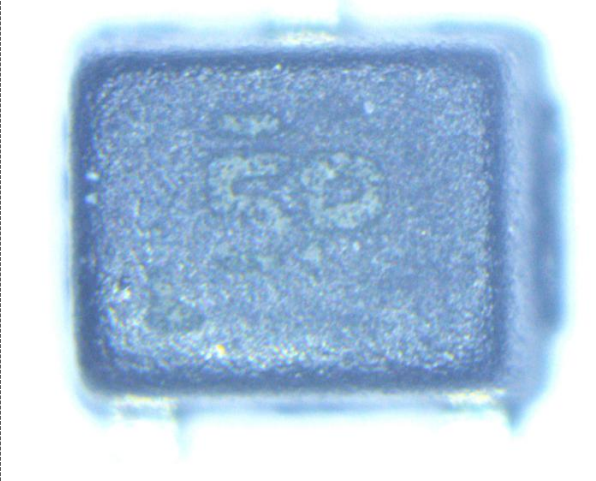
#1- Top permanency test

#1-Top Side
(Before Top permanency test)

#1-Top Side
(After Top permanency test)

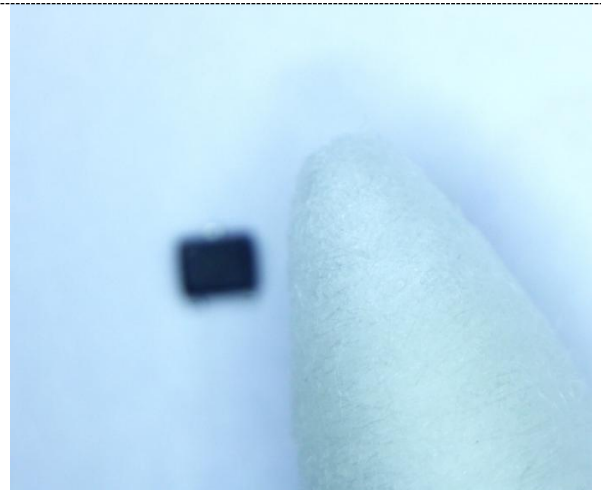
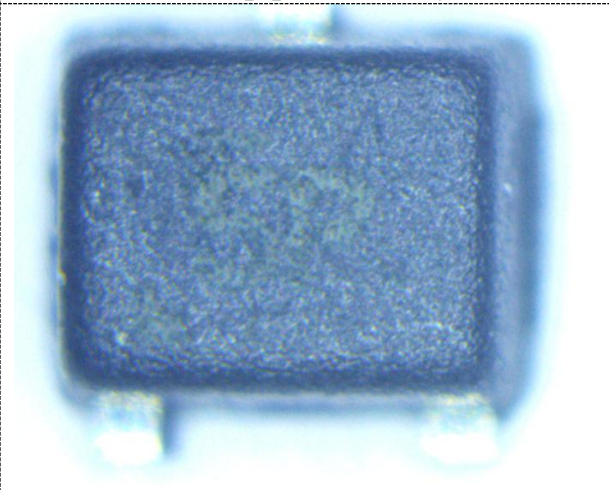
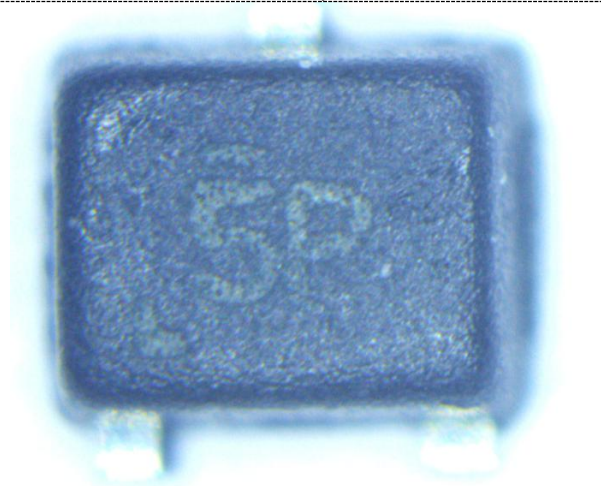
#2-Top permanency test

#2-Top Side
(Before Top permanency test)

#2-Top Side(After Top permanency test)

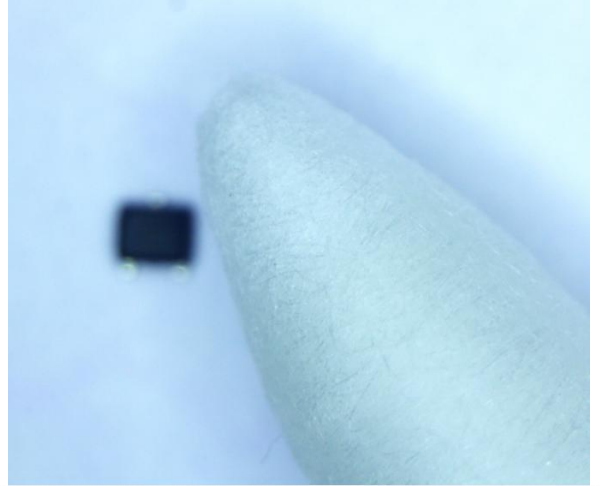
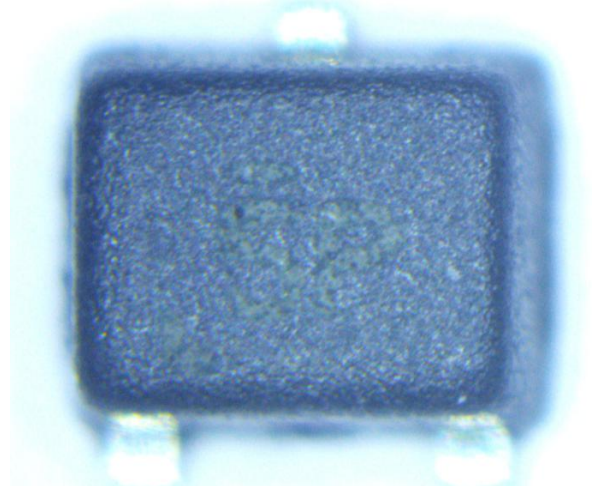
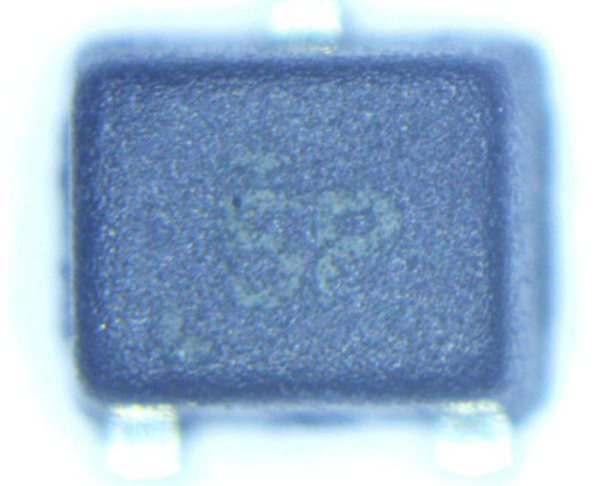
#3-Top permanency test

#3-Top Side(Before Top permanency test)

#3-Top Side(After Top permanency test)

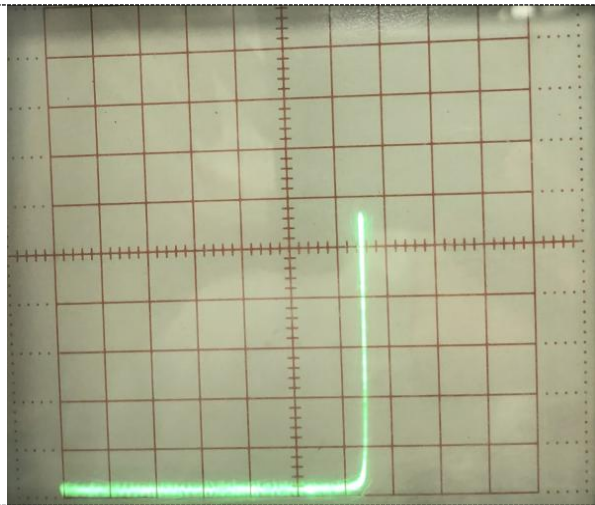
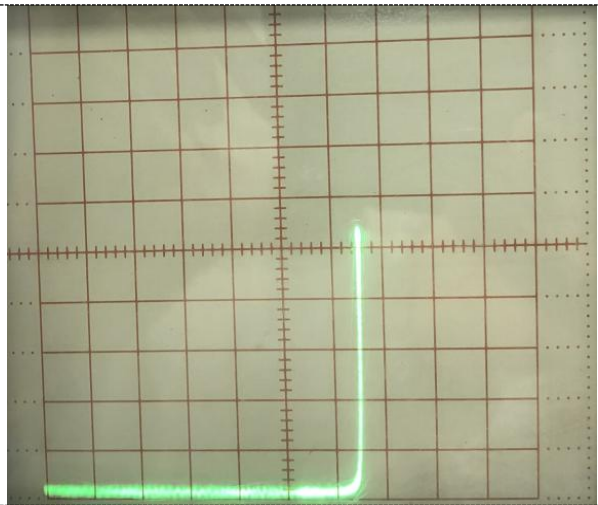
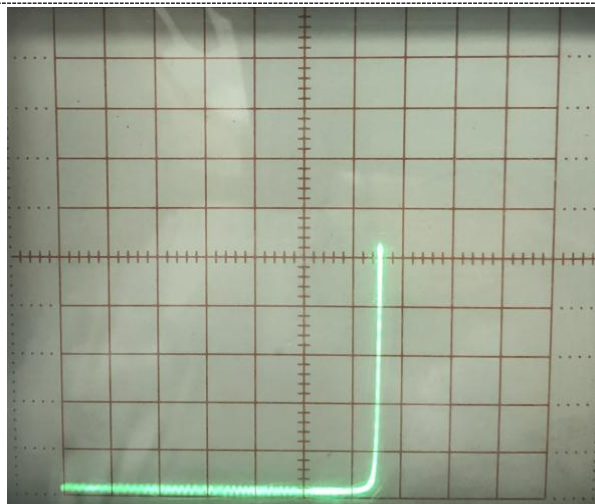
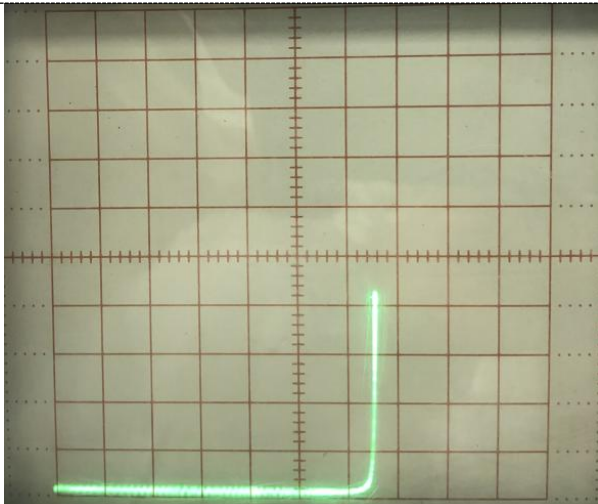
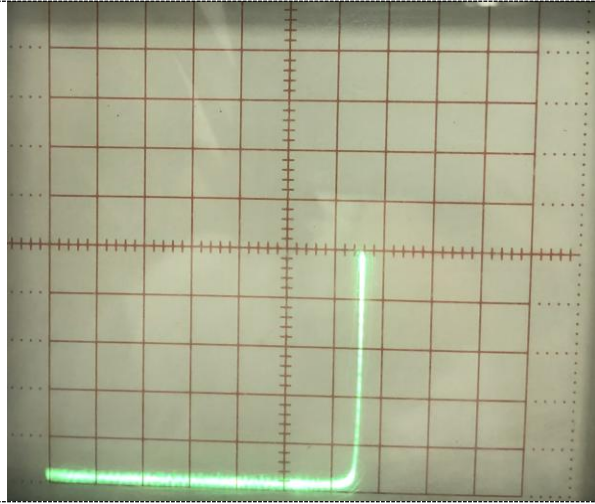
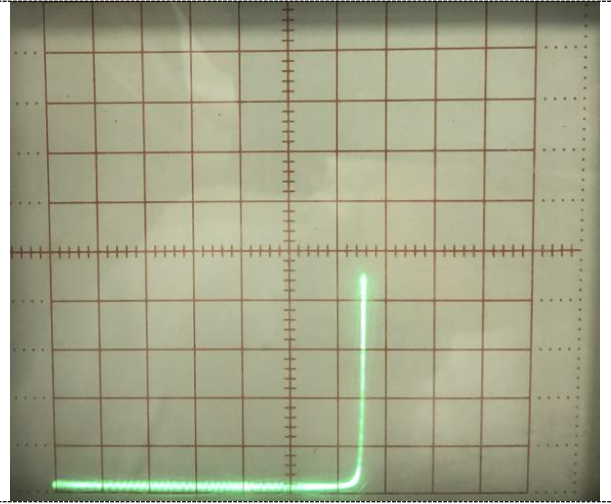
Using curve tracer verified the following parameters at 25°C:

-Break-down voltage: $V_{BR} = 7V \text{ Min @ } I_{IO} = 1mA;$

#1 - D⁺ TO GND: $V_{BR} = 15V$

#1 - D⁻ TO GND: $V_{BR} = 15V$

#2 - D⁺ TO GND: $V_{BR} = 15V$

#2 - D⁻ TO GND: $V_{BR} = 15V$

#3 - D⁺ TO GND: V_{BR} = 15V

#3 - D⁻ TO GND: V_{BR} = 15V

Key Functional Testing (KFT)	Result:
Total quantity tested:	3 PCS
Total quantity passed:	3 PCS
Total quantity failed:	0 PCS
Note:	All devices pass parameter test.

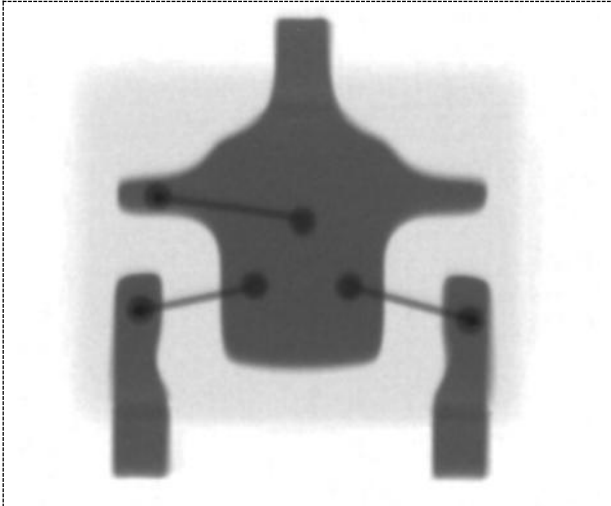
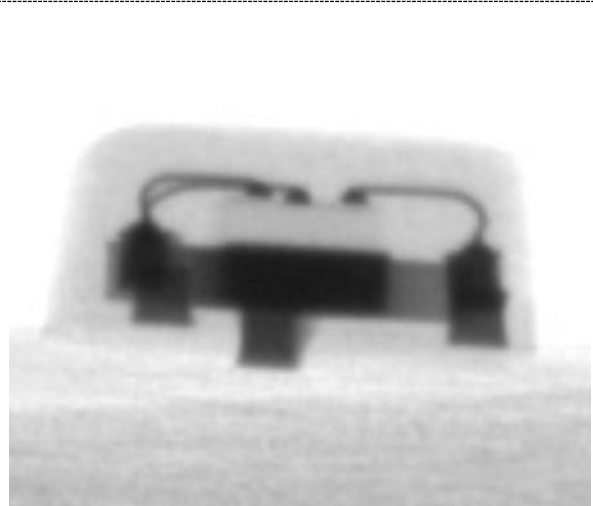
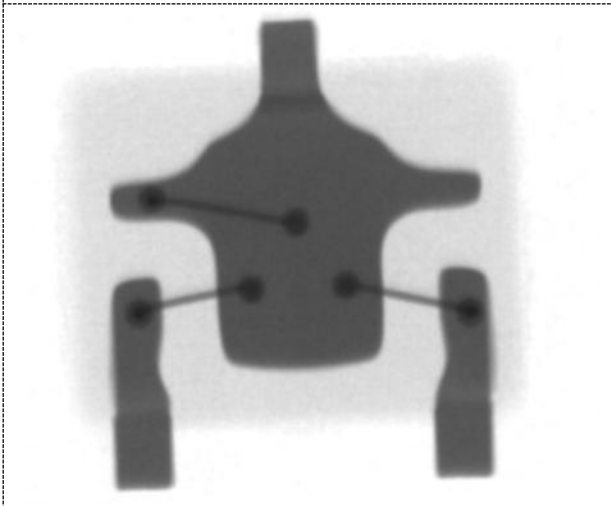
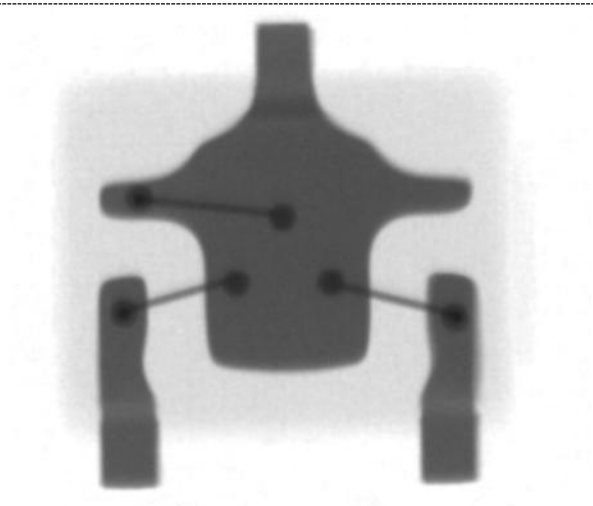
X-ray Inspection on 3 PCS (#1-#3) samples . No structure or bonding wire abnormal was found.

#1-Top View-All

#1-Side View-All

#2-Top View-All

#3-Top View-All

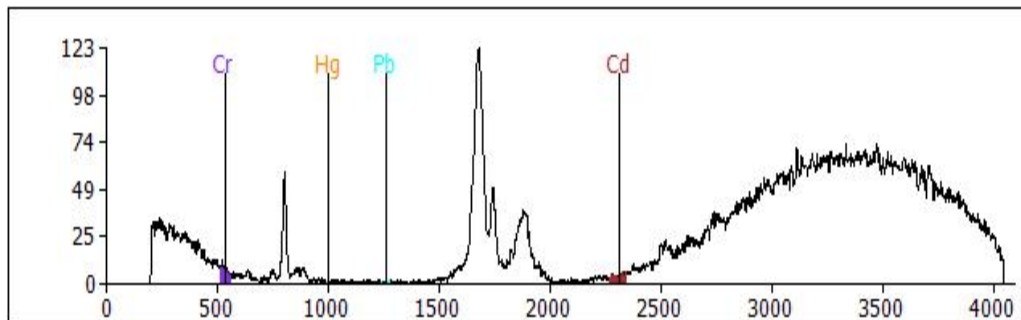
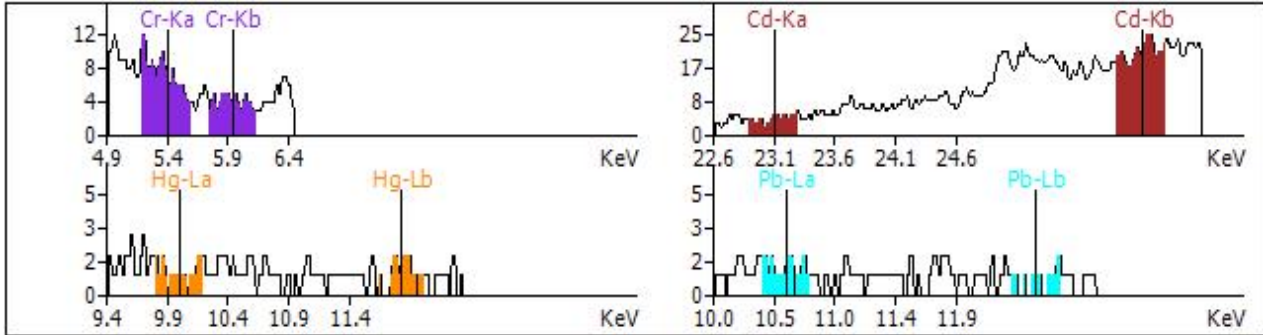
Spectrogram-1

ROHS testing on 3 PCS samples. Cr (ppm), Cd (PPM), Hg(ppm) and Pb (ppm) tests comply with ROHS standards.All samples pass the test.

#1						
Element	Intensity	Content (ppm)	Equipment	Error (ppm)	Limits (ppm)	Result
Cr(ppm)	0.00017	179.46	ICP-OES	9.62	1000	Pass
Cd(ppm)	0	ND	ICP-OES	0.00	100	Pass
Hg(ppm)	0	ND	ICP-OES	0.00	1000	Pass
Pb(ppm)	0	ND	ICP-OES	0.00	1000	Pass

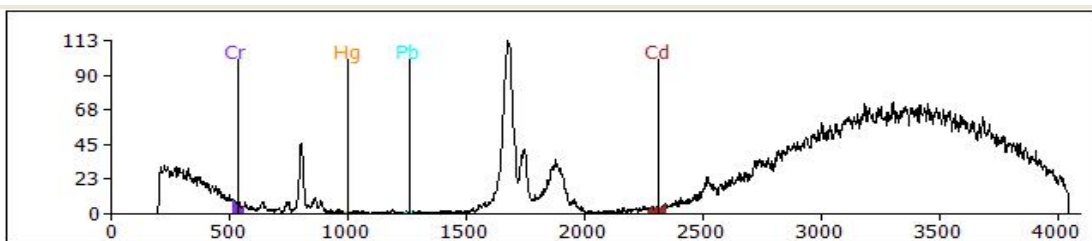
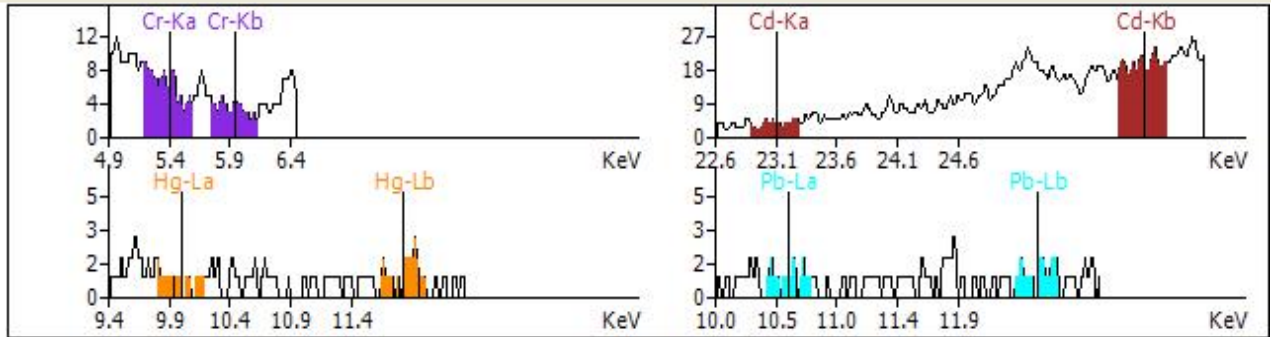
Spectrogram-1

Element	Intensity	Content (ppm)	Equipment	Error (ppm)	Limits (ppm)	Result
Cr(ppm)	0.00013	79.62	ICP-OES	4.55	1000	Pass
Cd(ppm)	0	ND	ICP-OES	0.00	100	Pass
Hg(ppm)	0	ND	ICP-OES	0.00	1000	Pass
Pb(ppm)	0.00017	842.62	ICP-OES	117.99	1000	Pass

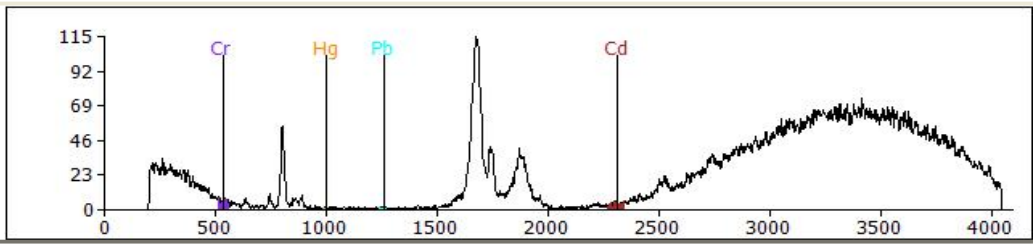
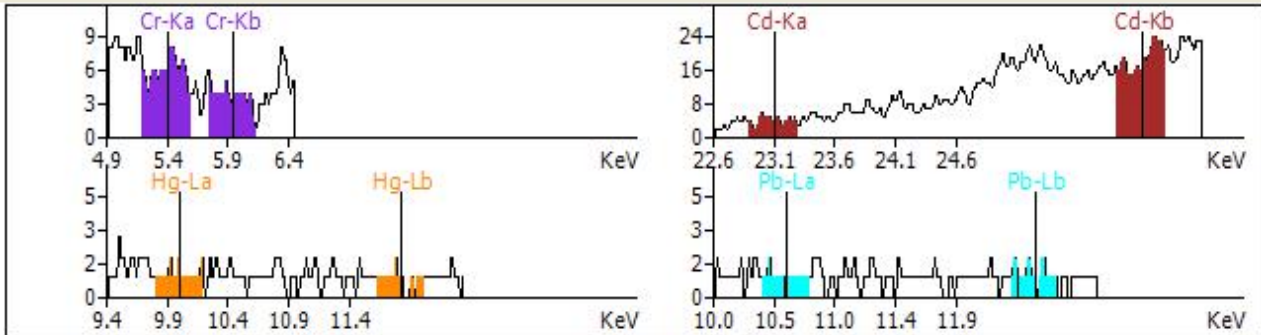
Spectrogram-1

Element	Intensity	Content (ppm)	Equipment	Error (ppm)	Limits (ppm)	Result
Cr(ppm)	0.00016	153.7	ICP-OES	9.04	1000	Pass
Cd(ppm)	0	ND	ICP-OES	0.00	100	Pass
Hg(ppm)	0.00009	ND	ICP-OES	0.00	1000	Pass
Pb(ppm)	0.00007	ND	ICP-OES	0.16	1000	Pass

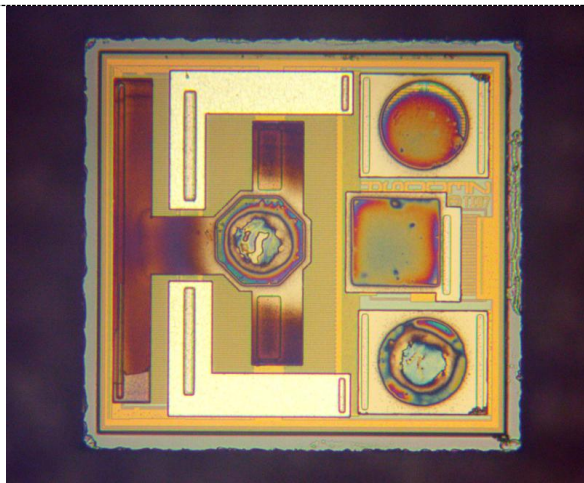
Die Topography

Internal Visual Inspection was verified on 1PCS sample. Manufacturer TI marking were found with 2007 copyright year. Die marking 2E009A were found on the die surface. Device confirmed to be a TI device.
