Report No:	SZ09022021004
Date:	2021/09/02
Page:	1/13

Project Inspection Report

Company : NA
Address : N/A
Sample Name : BAS20LT1G
Manufacture : SOT-23
Date Code : 1018,1111,1328,1538
Package Type : SOT-23
Sample Number : 4 PCS
Check Number : 4 PCS
Date of Received : 08/30/2021
Date of Tested : 17:10/09/01/2021 ~ 18:20/09/01/2021

Solderability Analysis:

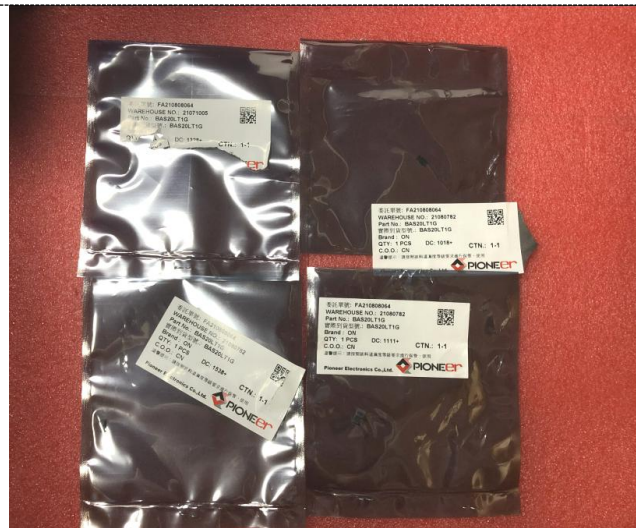
Received View-1

Gross Weight	36 g	Parts Total	4 PCS
Number Of Boxes	N/A	Full Label	Non Present
Package type	Reel	Moisture protection	Non Present
MSL	N/A	ESD protection	Acceptable

Note: All devices contain 1 PCS of D/C 1018 , 1 PCS of D/C 1111, 1 PCS of D/C 1328, 1 PCS of D/C 1538.

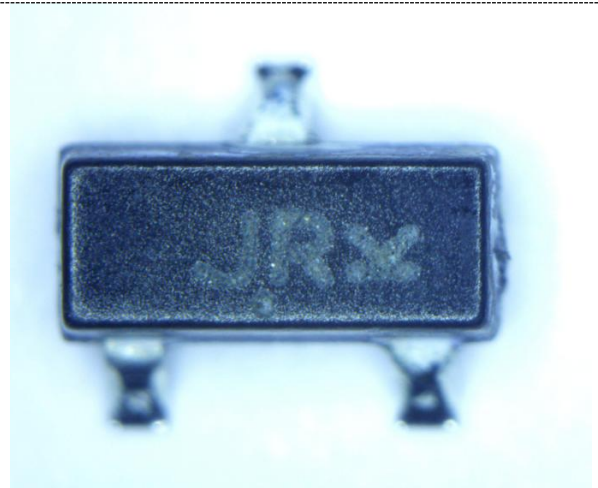
D/C1018 -After Top View

Solderability tested were performed on 4 PCS samples using the dip and look methods. 4 PCS pass solderability test. The dipped portion of the terminations is more than 95% covered by a continuous new solder coating.
